Client Name: Fort Meade

Fort Meade EBS for EUL

Project No. 15296957

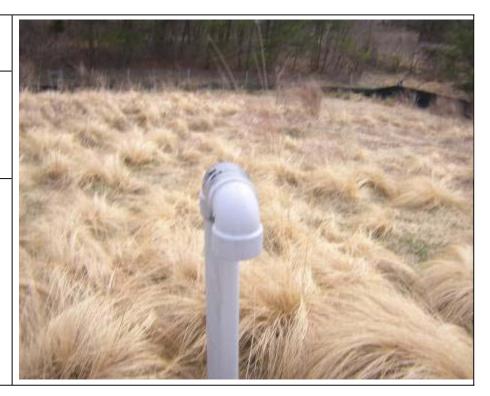
Photo No. S-2

Site S. Southwestern portion of landfill on site looking south at typical methane vent in landfill.

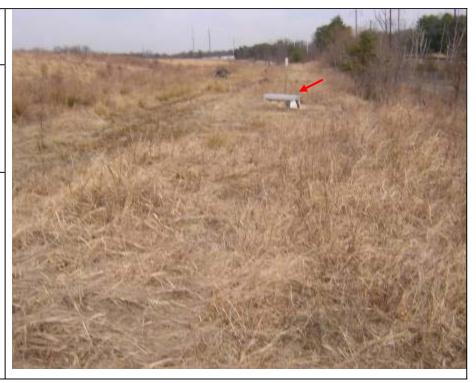
Photo No. S-3

Site S. Southeastern portion of site looking northeast at typical methane collection box for landfill.

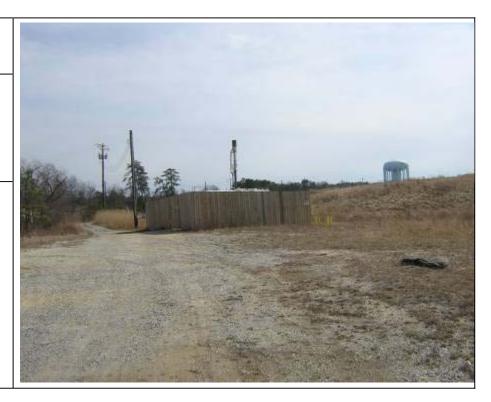
Photo No. S-4

Site S. Southeastern portion of site looking south at methane collection enclosure.

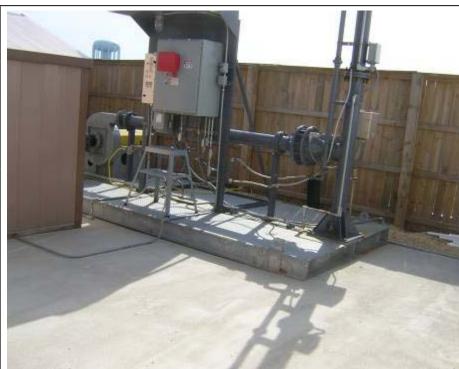
Photo No. S-5

Site S. Eastern portion of site looking west at methane collection pump.

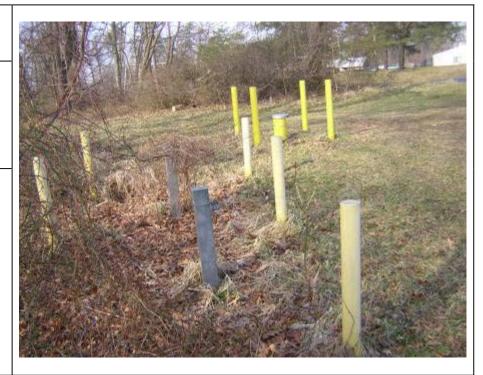
Photo No. S-6

Site S. Northwest portion.
Typical series of wells near the landfill.

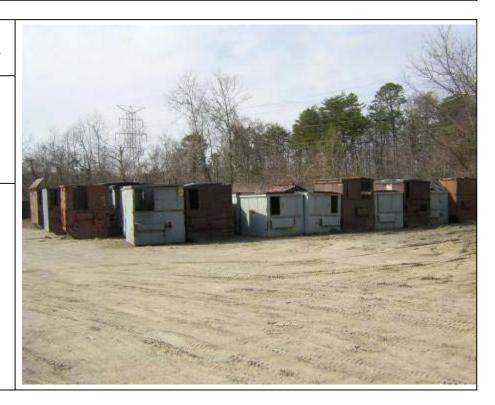
Photo No. S-7 **Date:** Mar 17, 2005

Site S. Eastern portion of site.
Unused dumpsters being stored on site.

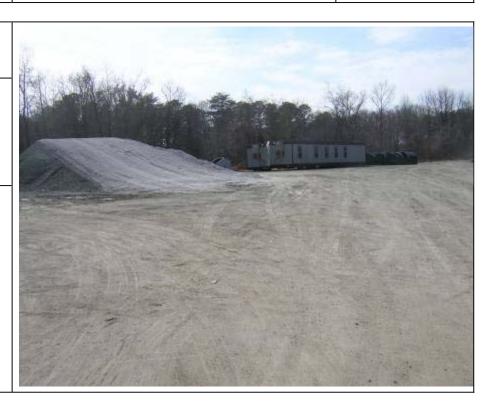
Photo No. S-8

Site S. North-central portion of site. Unused trailers in background and gravel pile to left of figure.

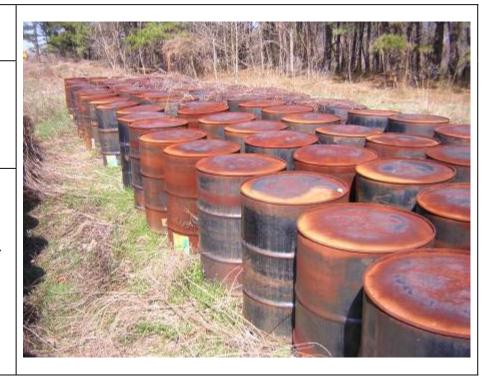
Photo No. S-9 A

Site S. Old drum storage area. Drums appear to be upside down and apparently empty.

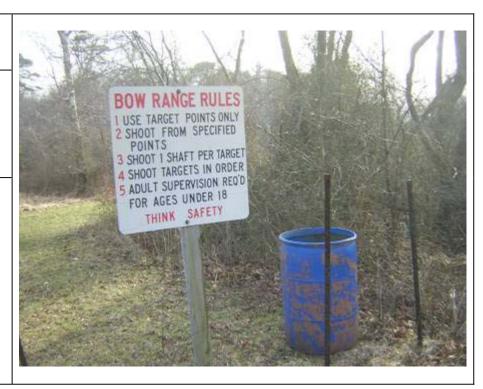
Photo No. S-10

Sign at start of archery range.

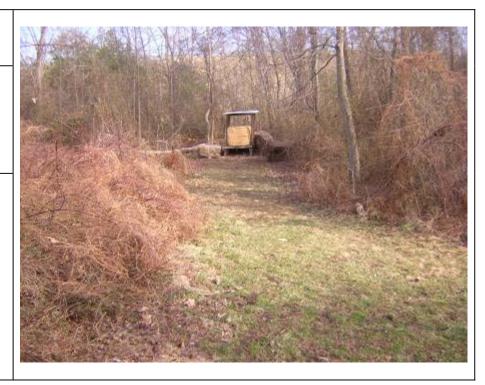
Photo No. S-11

Site S. Northwest section. Typical target area at archery range.

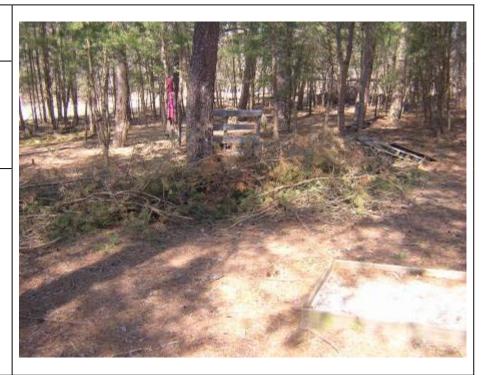
Photo No. S-12

Site S. Training course in southern portion of site.

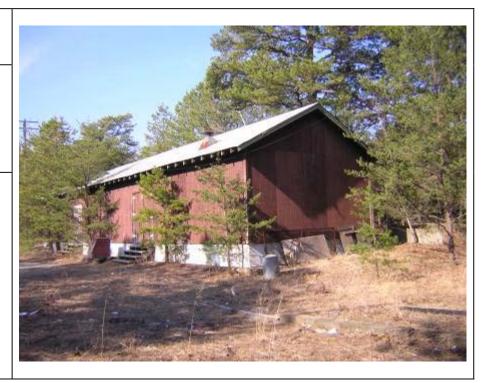
Photo No. S-13 **Date:** Mar 22, 2005

Site S. Southern section. Target Shed 8. Old coal bin in right-center of photo.

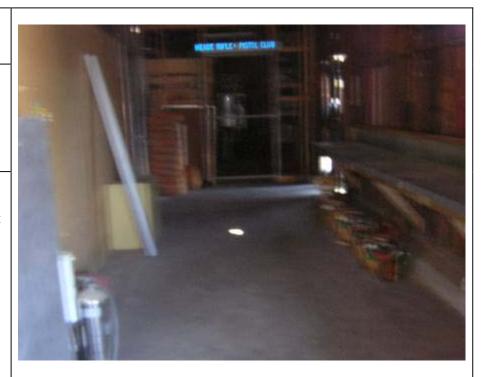
Photo No. S-14

Site S. Southern section. Inside Target Shed 4.

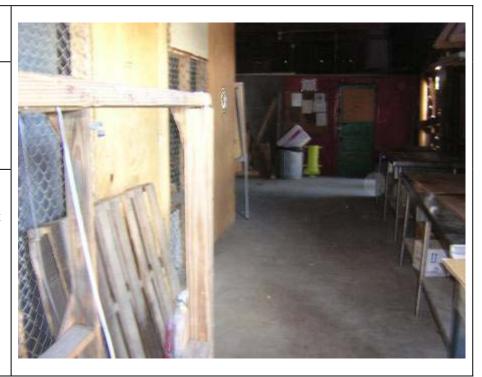
Photo No. Date: S-15 Apr 4.

Site S. Southern section. Inside Target Shed 8.

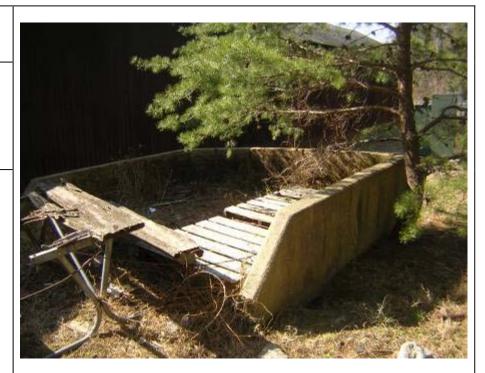
Photo No. S-16

Site S. Southern section. Old coal bin southeast of Target Shed 4.

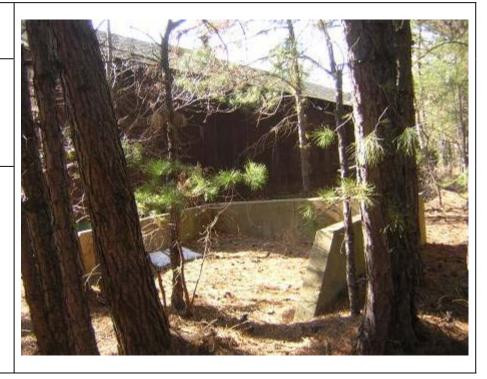
Photo No. S-17

Site S. Southern section. Old coal bin southeast of Target Shed 8.

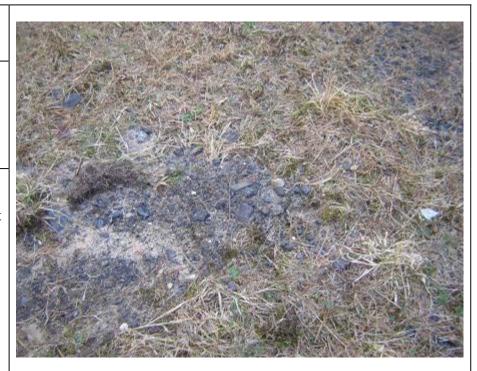
Photo No. S-18 **Date:** Mar 22, 2005

Site S. Southern section. Coal adjacent to old coal bin at Target Shed 4.

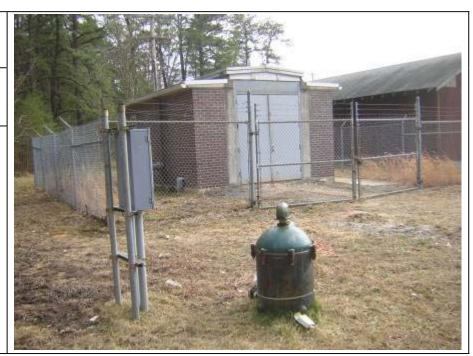
Photo No. S-19

Site S. Southwestern portion of site. Well and pump house for water supply for base. Well in foreground, pump house is brick building with grey metal doors in background. Target shed 4 is to the right in the background.

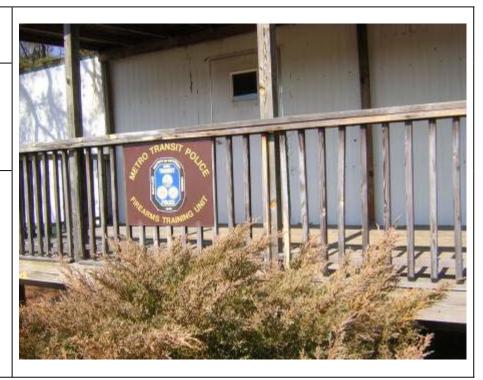
Photo No. S-20

Site S. Southern section. Metro Transit Police trailer.

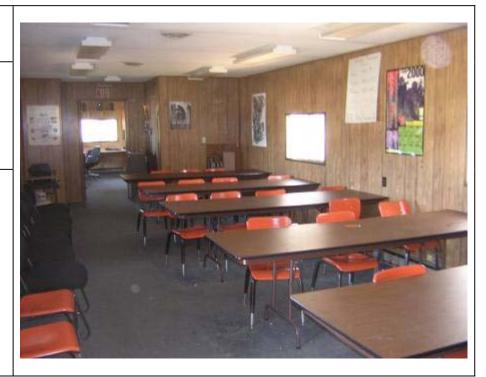
Photo No. S-21

Site S. Southern section. Inside Metro Transit Police trailer.

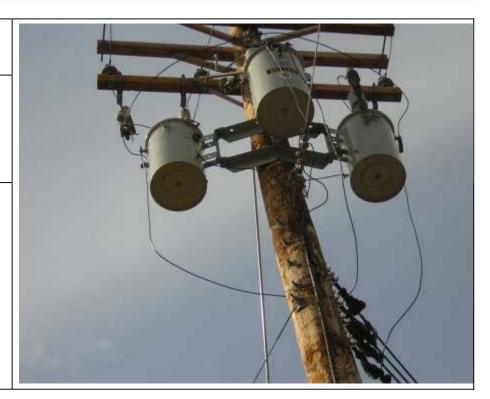
Photo No. S-22

Site S. Eastern portion of site looking east at polemounted transformers. Blue "non-PCB containing" labels visible.

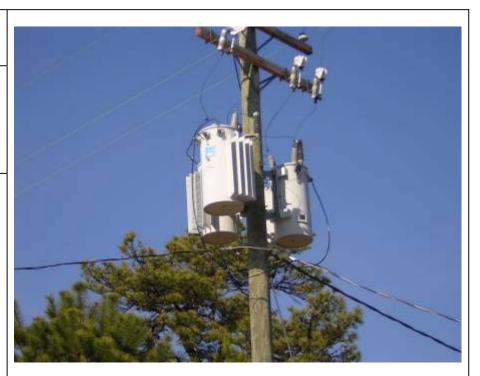
Photo No. Date: S-23

Site S. Southwest section. Polemounted transformers next to target shed 8. Blue "non-PCB containing" tag visible on transformers.

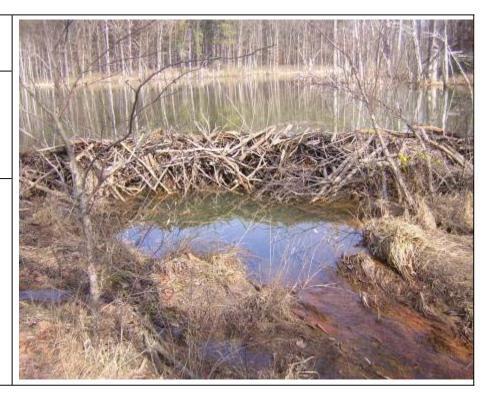
Photo No. S-24

Site S. Northwestern portion of site. Beaver dam.

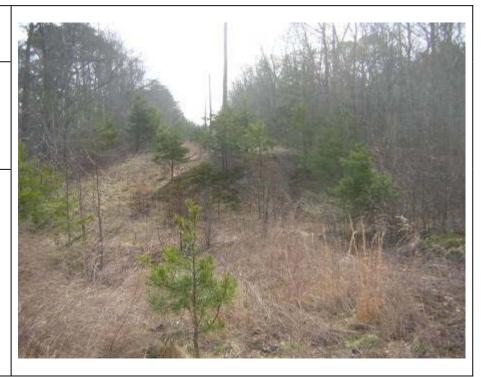
Photo No. S-25

Site S. Northern section. Looking down old railroad spur.

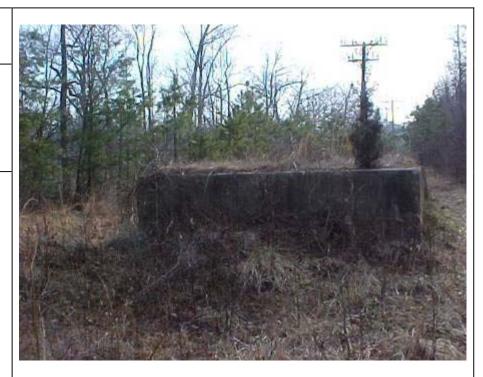
Photo No. S-26

Site S. Northern section. View of a former railroad loading dock on top of the old railroad grade.

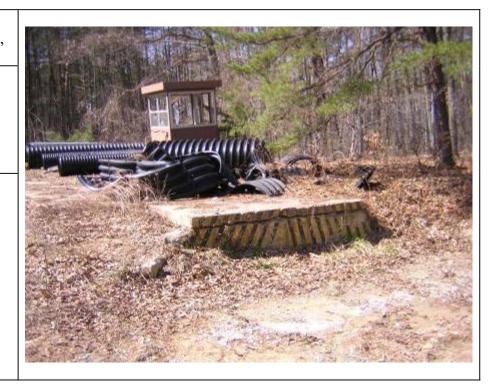
Photo No. S-27

Site S. Northwest section. Old foundation.

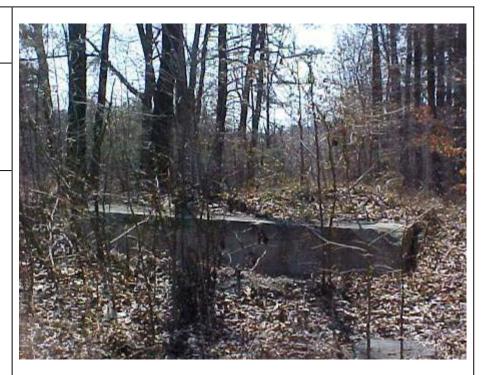
Photo No. S-28

Site S. Northwest section. View of an old building foundation.

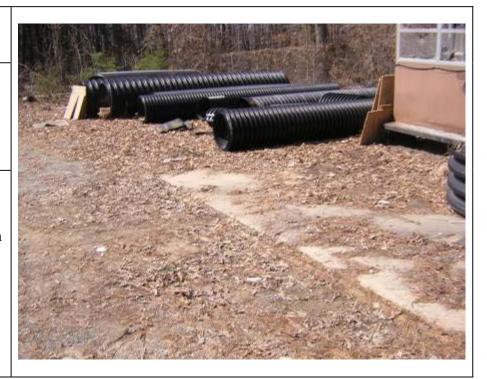
Photo No. S-29

Site S. Foundation in northwestern section of site may have been a scale for weighing vehicles entering landfill area.

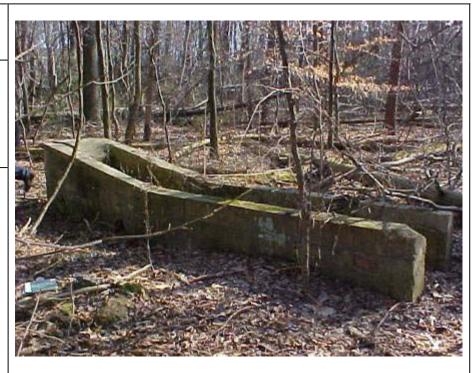
Photo No. S-30

Site S. Northern section. View of an unidentified, concrete trough-like structure with a slope on one end.

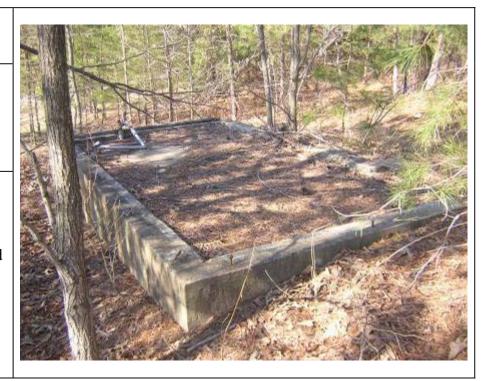
Photo No. S-31

Site S. Southern section. Old foundation near current pole-mounted transformers near Target Shed 8.

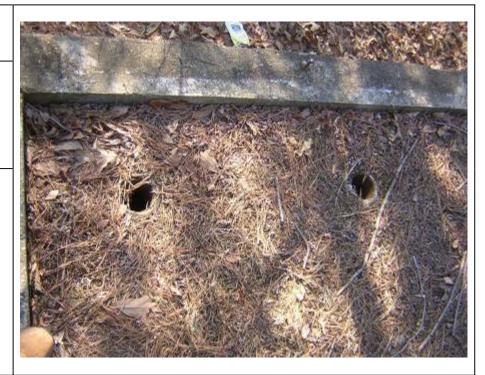
Photo No. S-32

Site S. Southern section. Holes in old foundation, could have been conduits for wires if foundation was for a transformer.

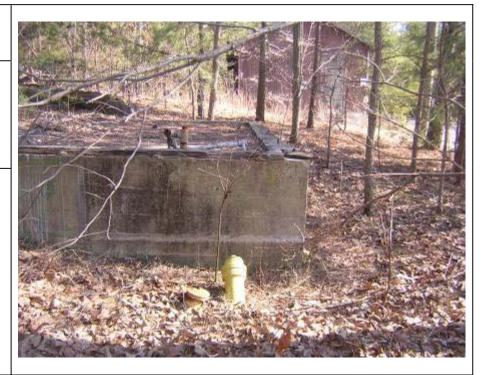
Photo No. S-33

Site S. Southern section. Water and sanitary sewer access adjacent to old foundation with pipes. Target Shed 8 is in background.

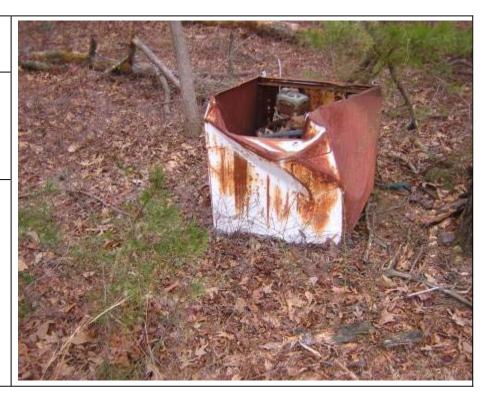
Photo No. S-34

Site S. Southeastern portion of landfill looking west at abandoned washing machine outside fenced-in portion of landfill.

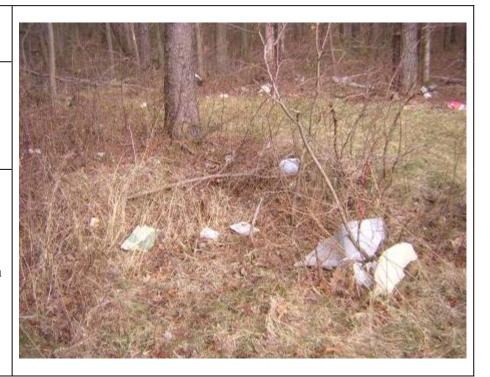
Photo No. S-35

Site S. Southern portion of site. Office/household trash on ground. Location not far from Metro Transit Police trailer and Target Shed 4.

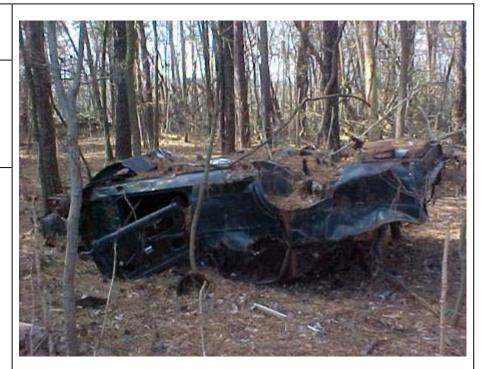
Photo No. S-36

Site S. Northeast section. View of an old car that has been dumped in the northeast corner of the site.

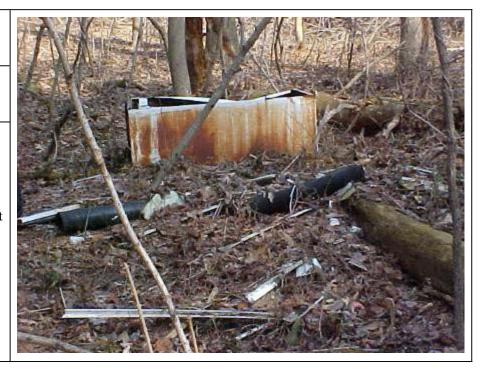
Photo No. S-37

Site S. Northeast section. View of an old refrigerator and scrap metal that has been dumped in the northeast corner of the site just south of the residences. Nearby, other items that have been dumped are a washing machine, stove, tires, and tarps.

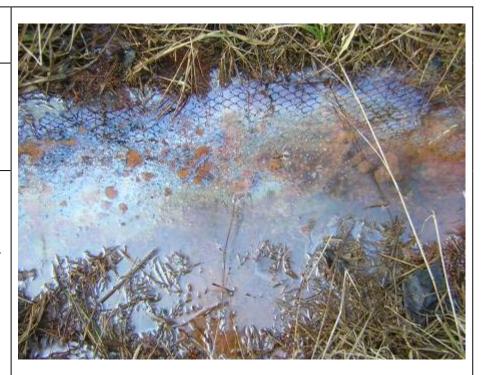
Photo No. S-38

Site S. North-central section. Sheen on water in marshy area. This section was near a break in the fence and downhill of the drum storage area.

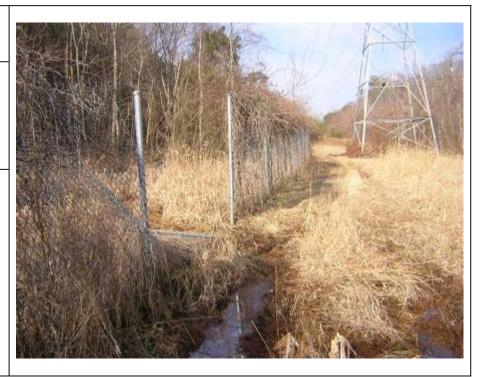
Photo No. S-39

Site S. North-central section showing break in fence around landfill. Landfill to the left of photo. Drum storage area behind trees to left of photo. Sheen on water in foreground.

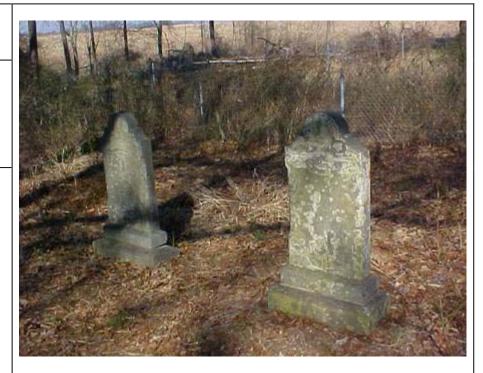
Photo No. S-40

Site S. Eastern section. View of two headstones in the Phelps cemetery. There are remains of two other headstones to the left.

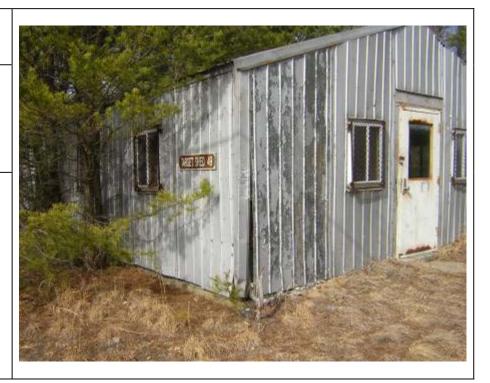
Photo No. S-41

Site S. Target Shed 49 located west of site. Cardboard backing for targets stored inside.

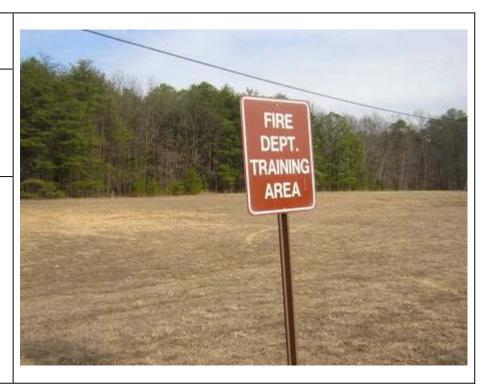
Photo No. S-42

Site S. Fire Training Area located west of site.

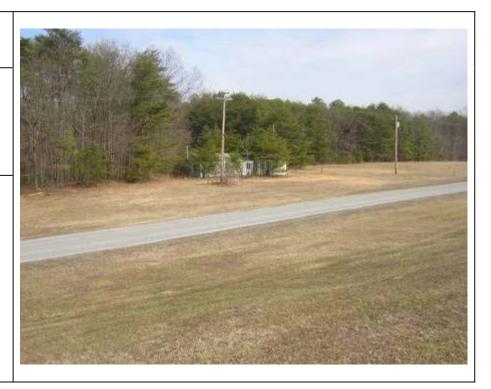
Photo No. S-43

Site S. Northwestern portion of site. Fire Training Area to upper right of photo. Pole mounted transformer on pole in upper right of photo.
